Community Meeting

September 9, 2004

Hosted by the Department of Energy

Sources of Tritium at Santa Susana Field Laboratory

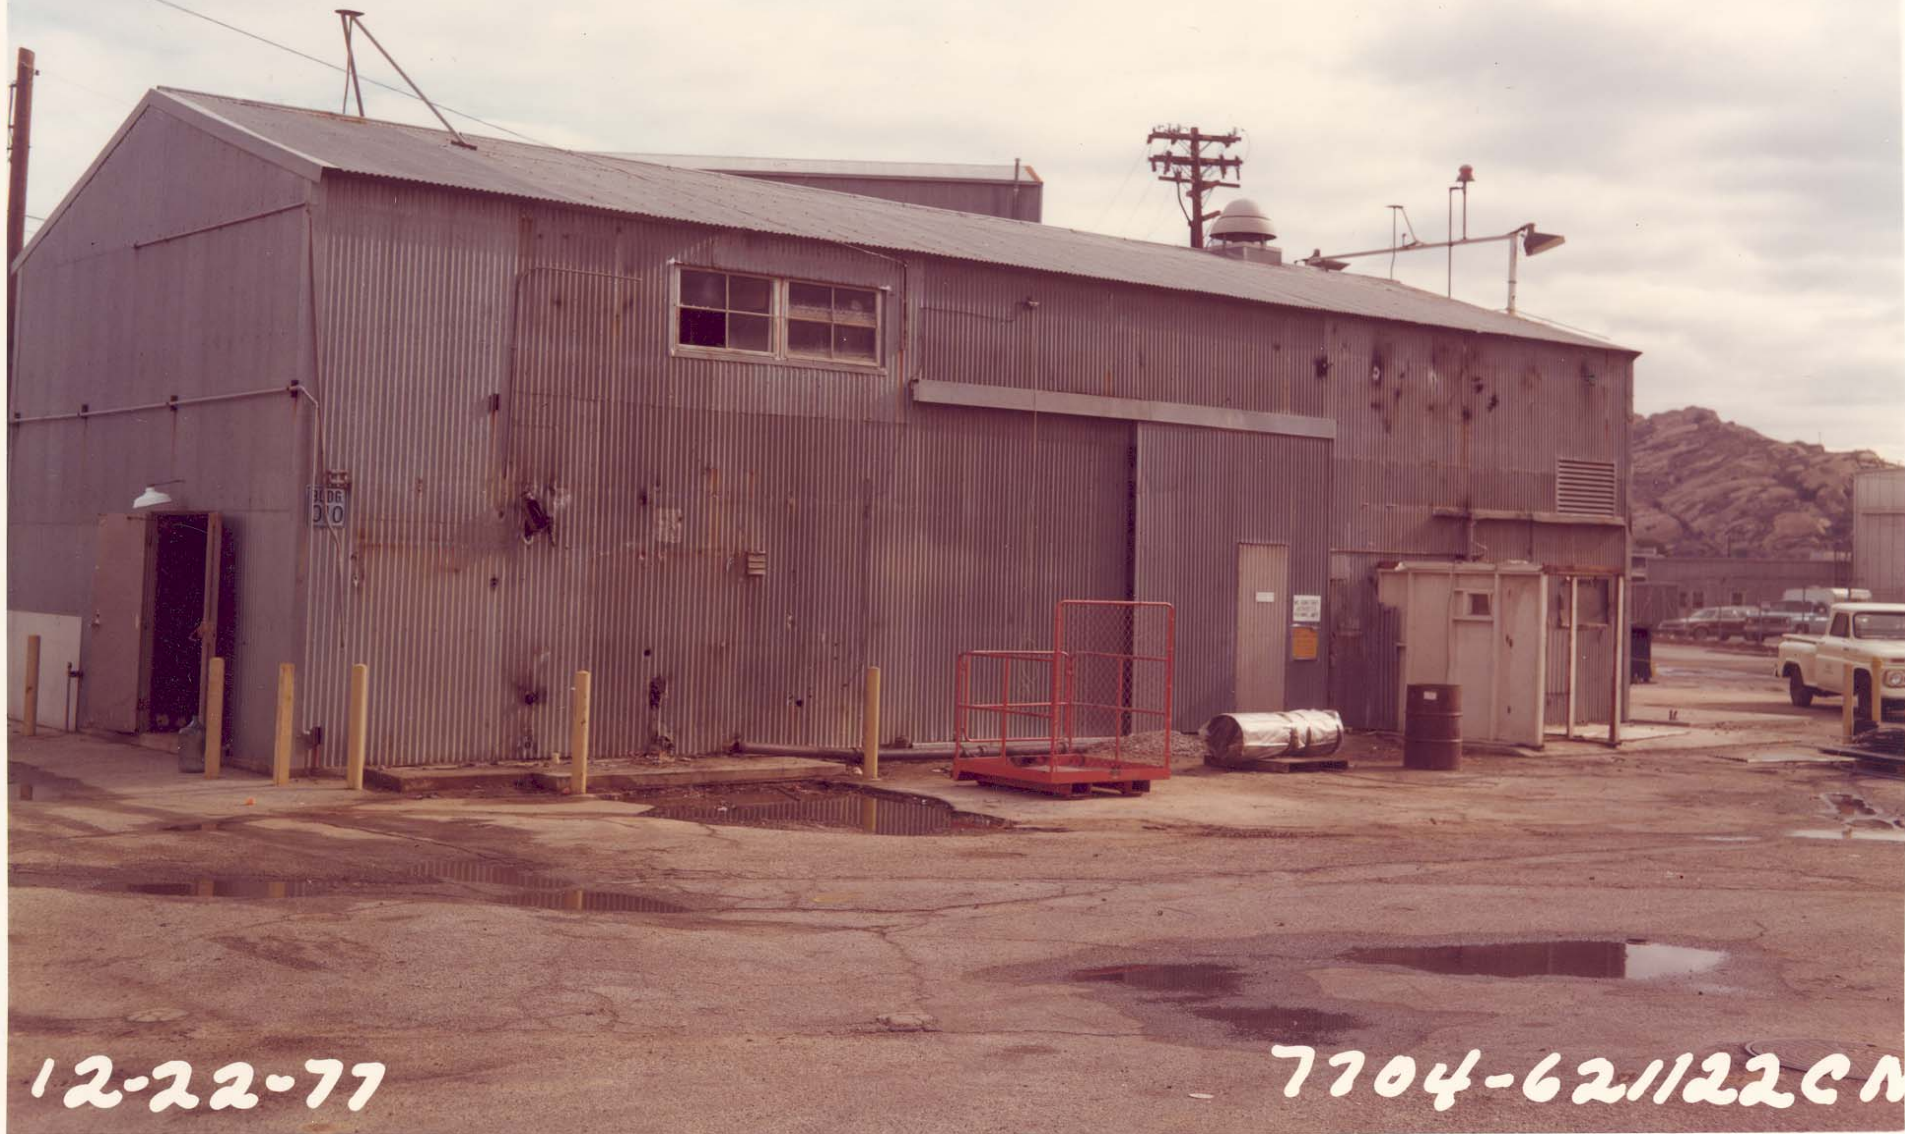
Building 10, Systems for Nuclear Auxiliary Power 8 Experimental Reactor Facility

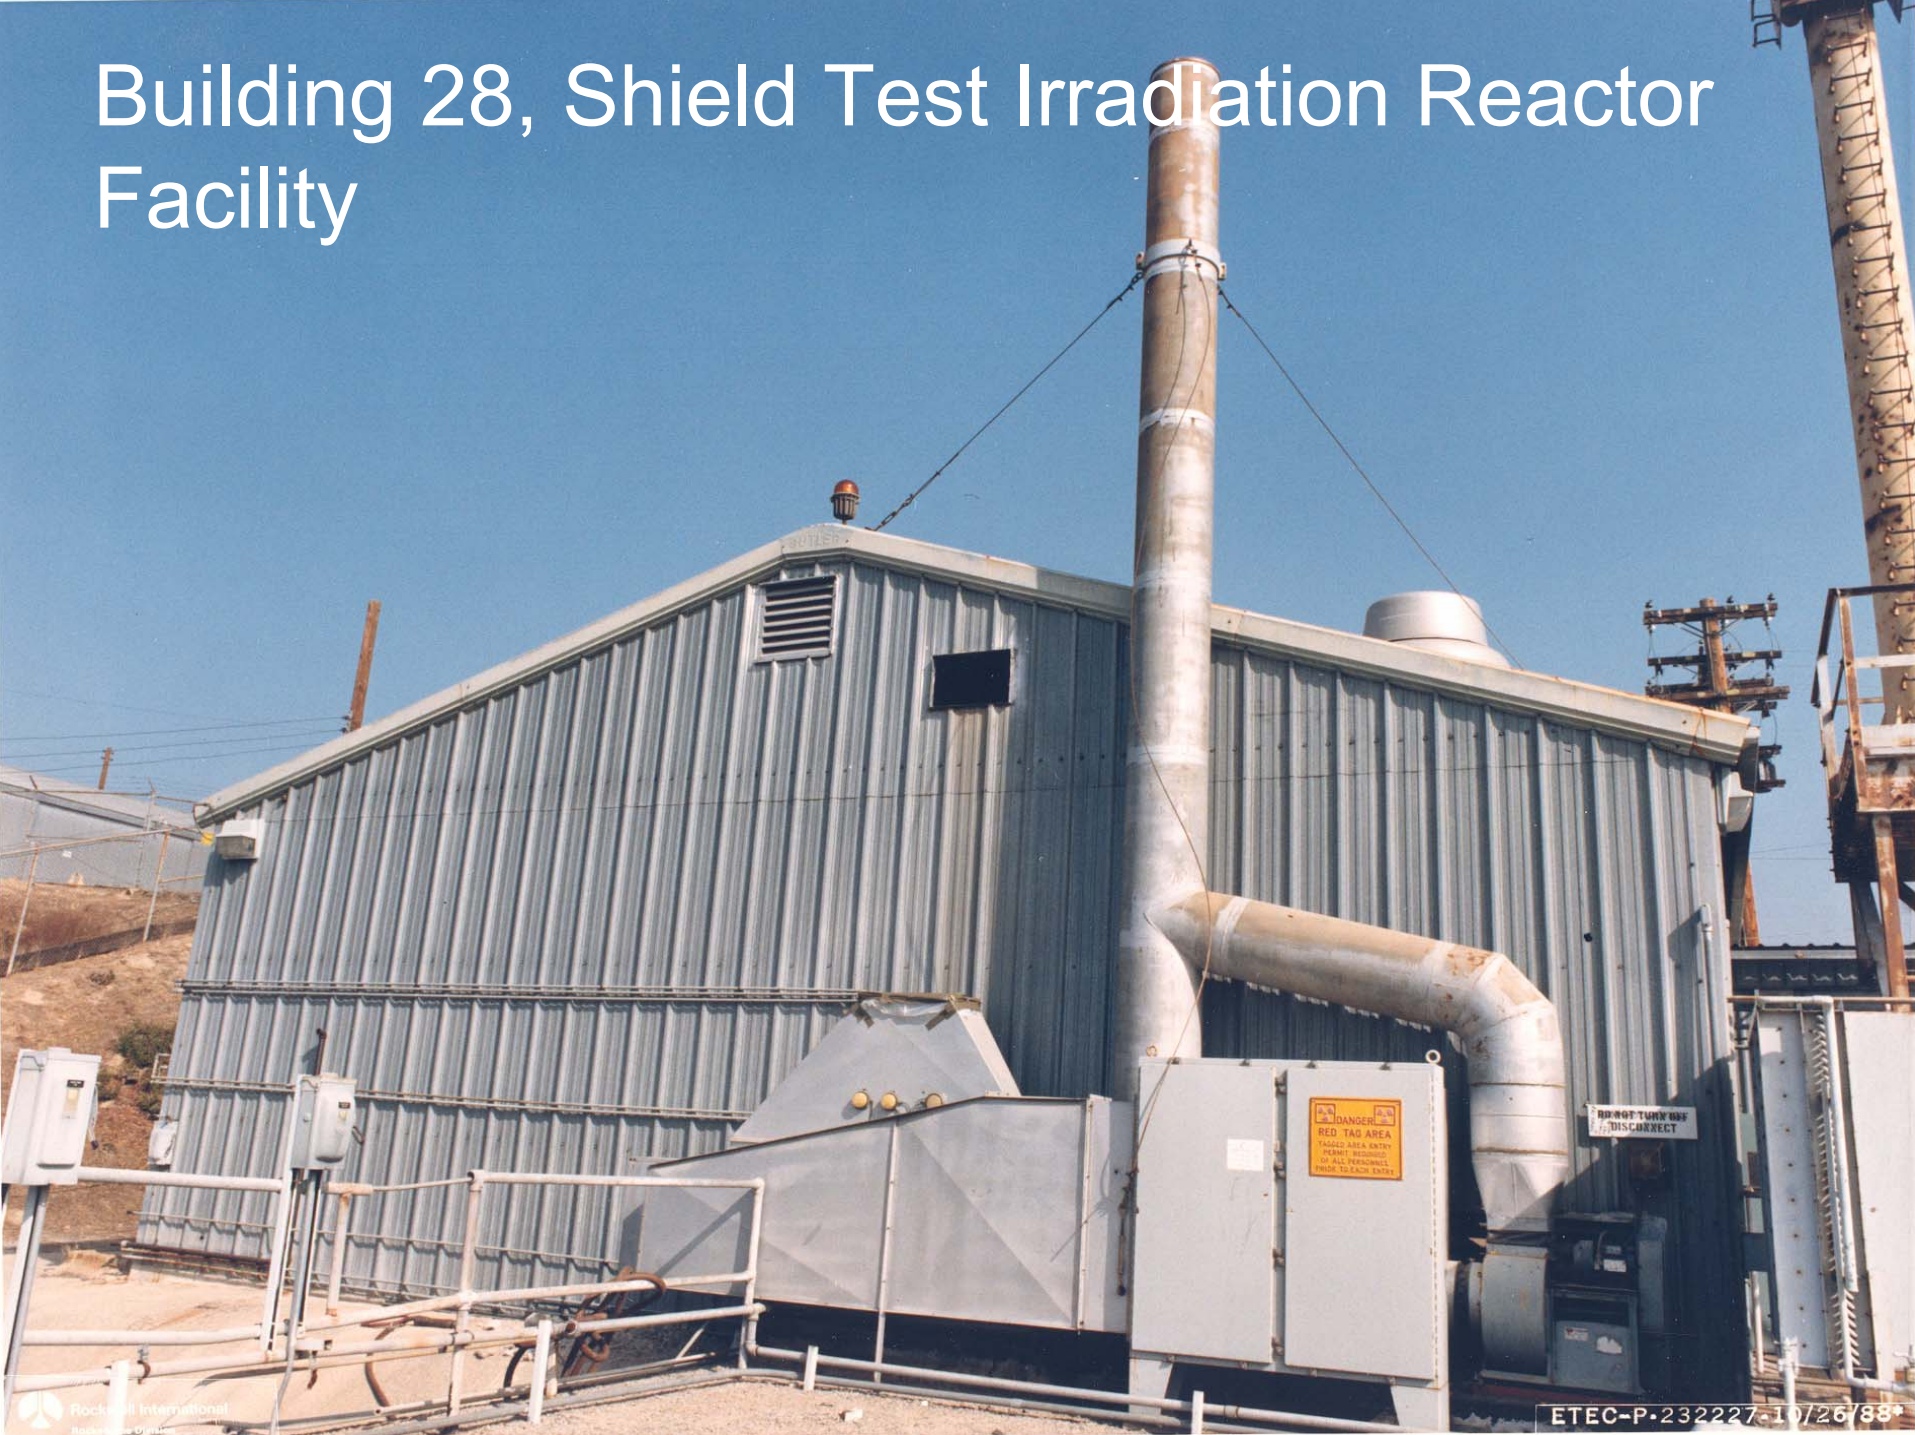
Building 28, Shield Test Irradiation Reactor Facility

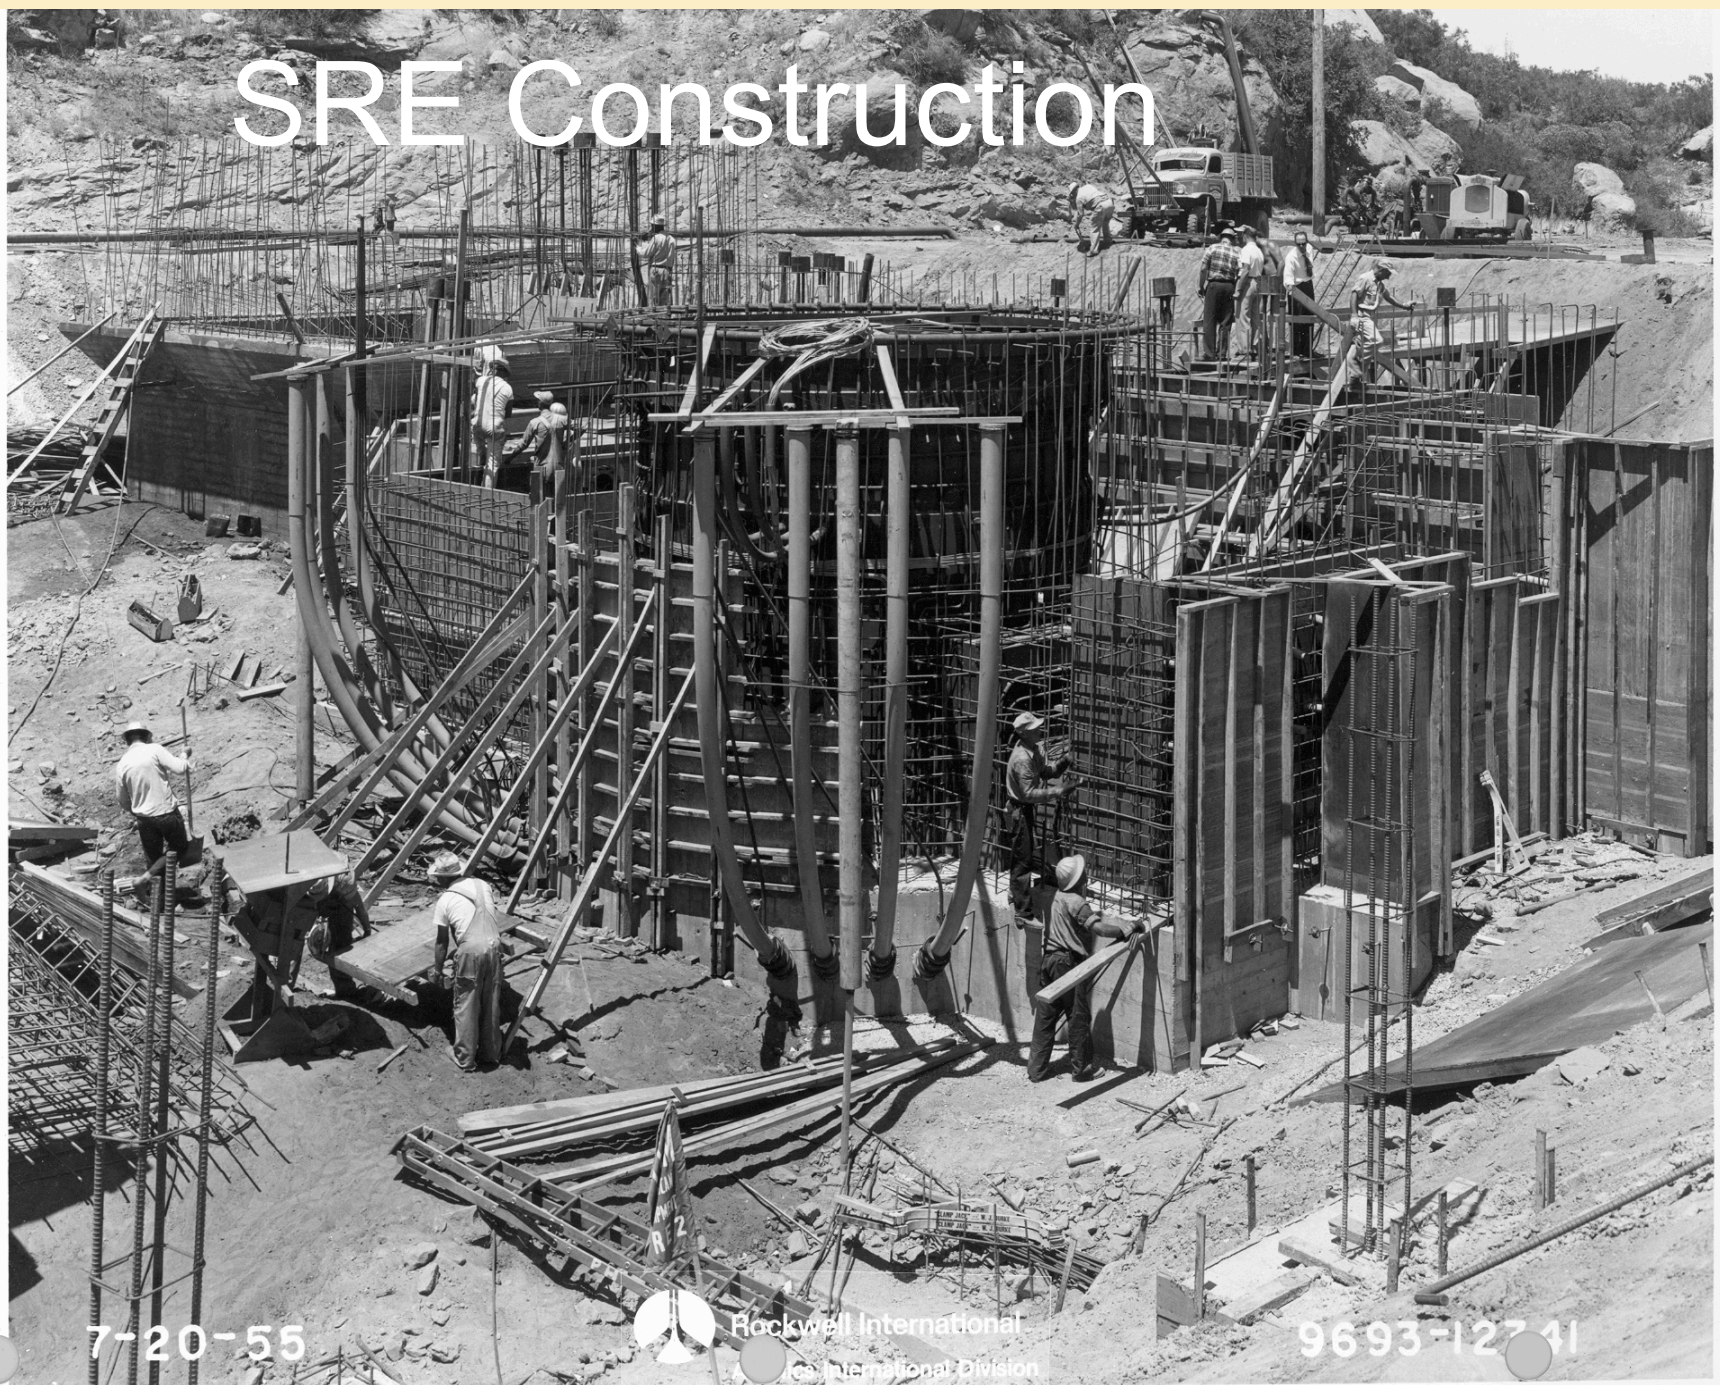
SRE Construction

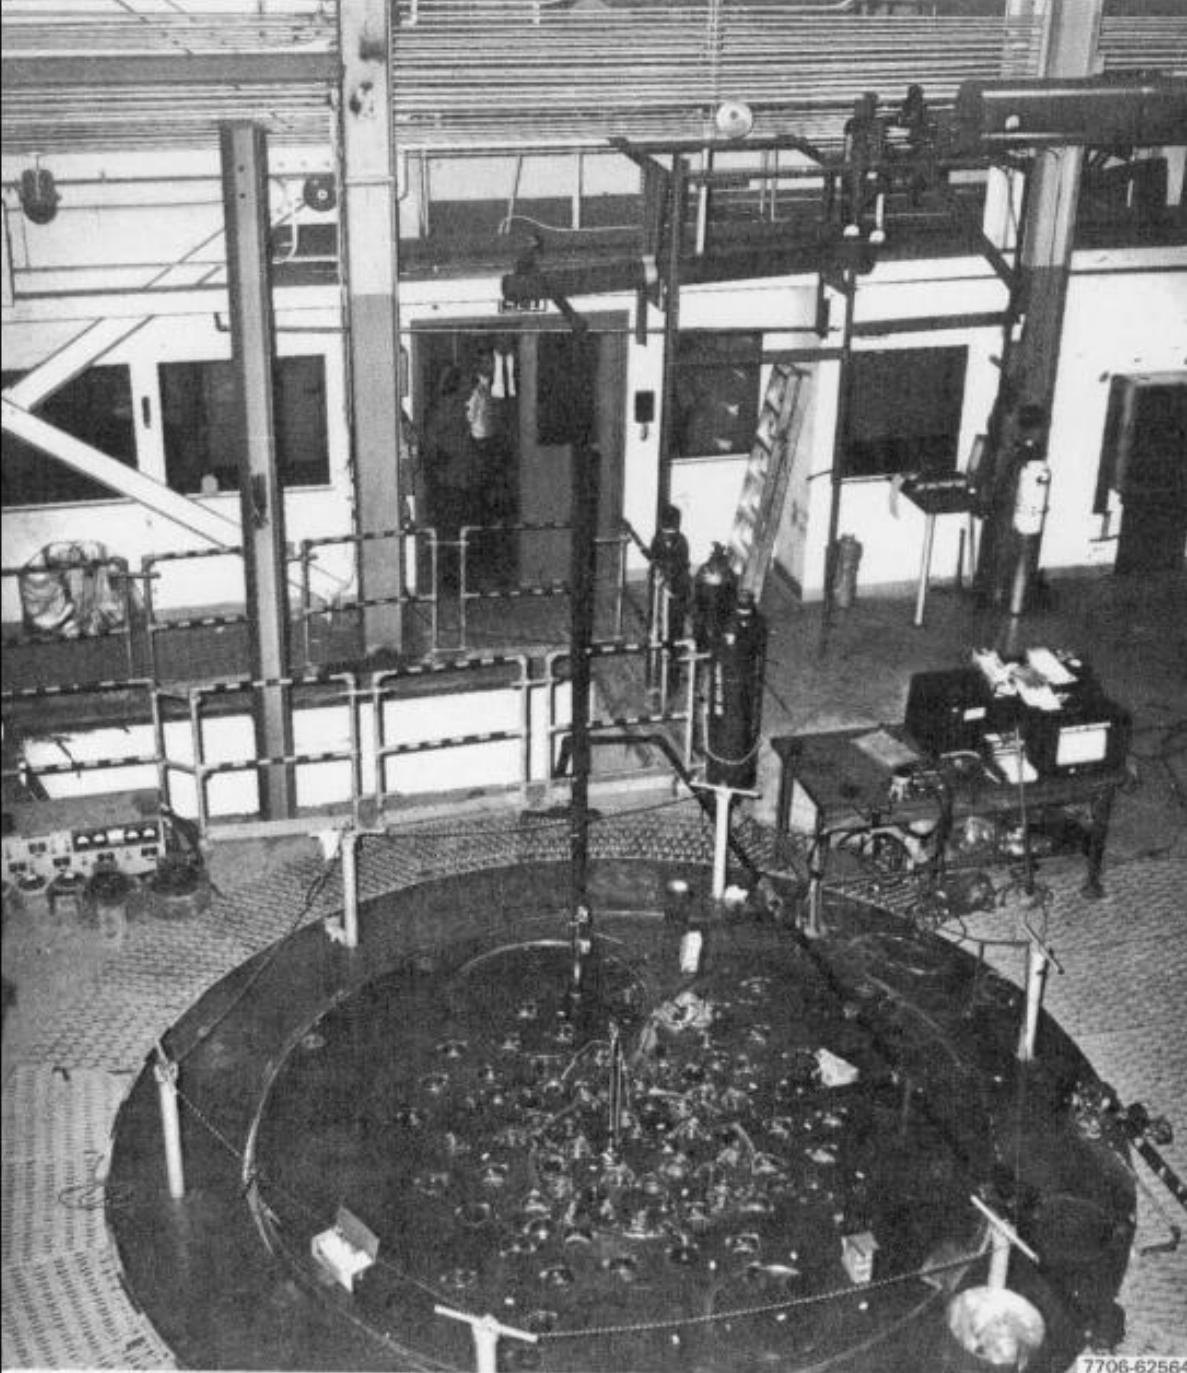
SRE Refueling Head

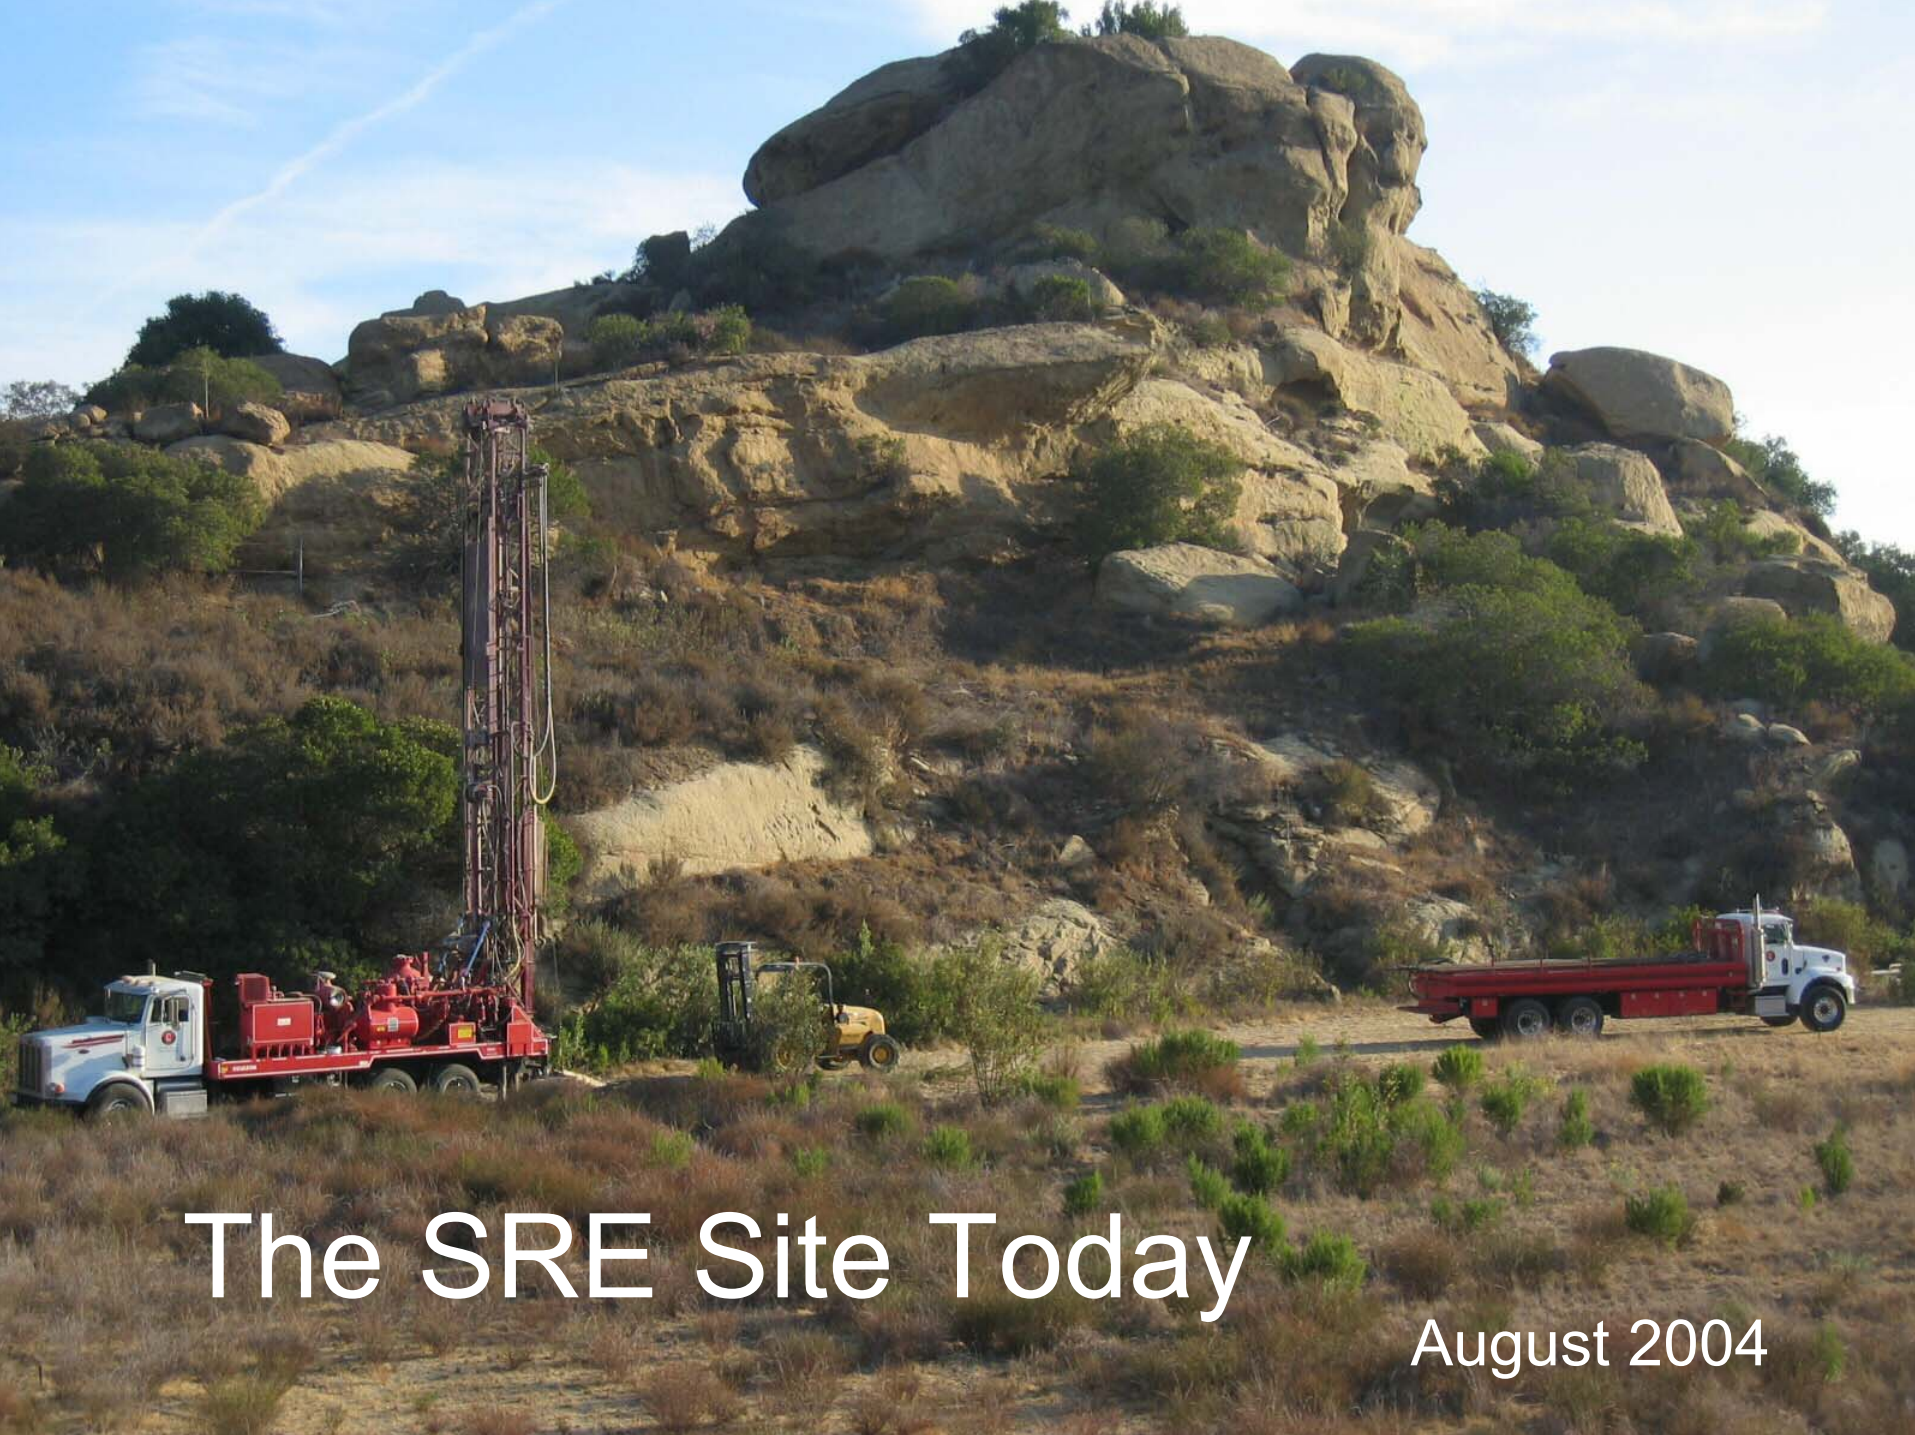
- A new core and new sodium coolant were loaded and the reactor continued operation from 1960 -1964.
- Decontaminated in early 1970's, released for unrestricted use.
- Building used for storage.
- In 1999, the SRE facility was completely demolished.

The SRE Site Today
